# Inspection Report

## Profile Building and Pest Inspections

**123 Inspection St , Inspection Town , QLD, 1234**

### Pest And Building Inspection

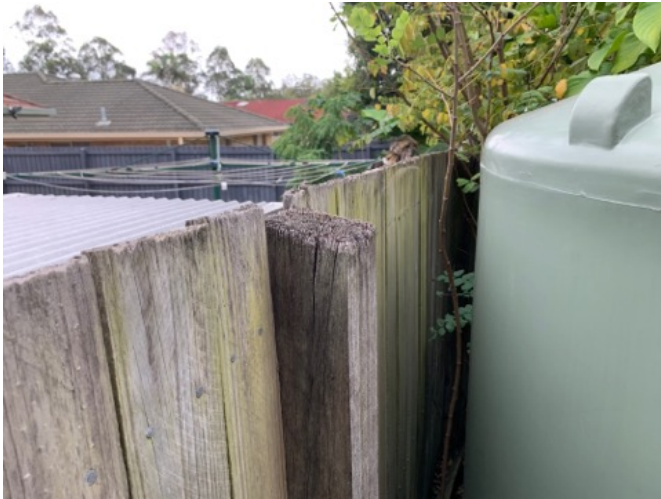
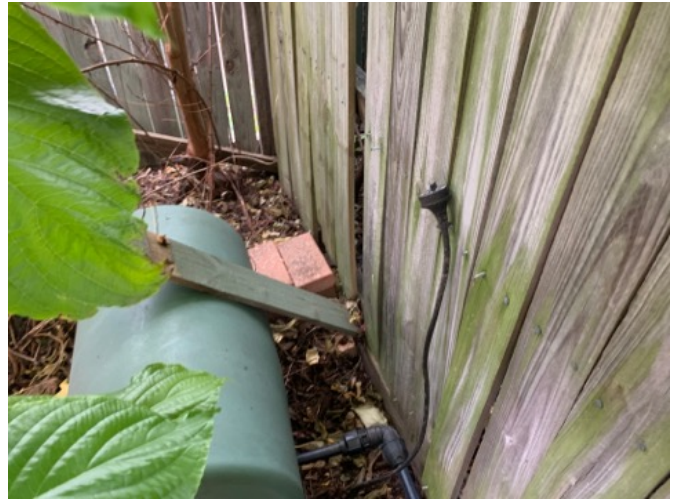
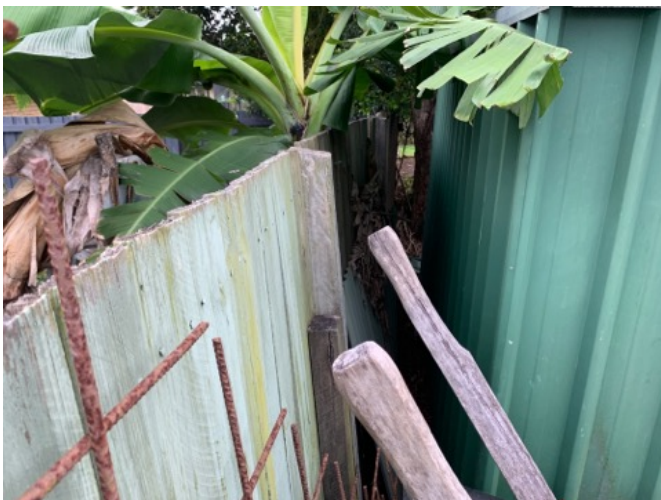
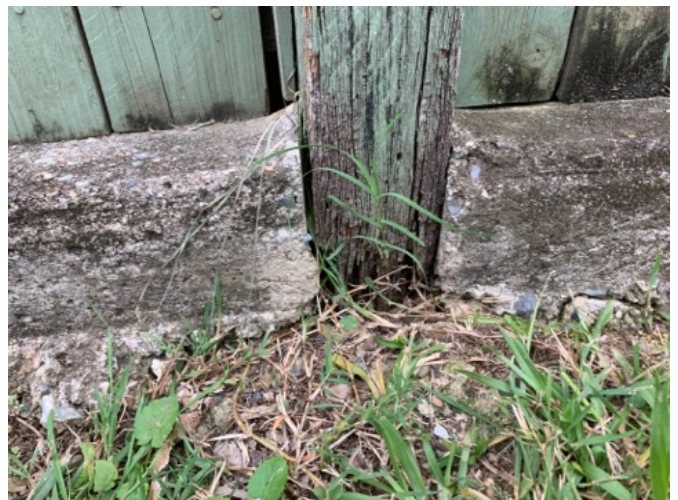
Timber fences are leaning over in some sections. Repairs are recommended  
General weathering and decay to fence components - Recommendations: Repair and replace affected areas. A qualified fencing contractor should be engaged for repairs  
Damaged, loose or missing palings in some sections. Contact a fencing contractor for repairs.  
Base of timber posts is decayed effecting the integrity of the post. Replace/ repair posts as necessary

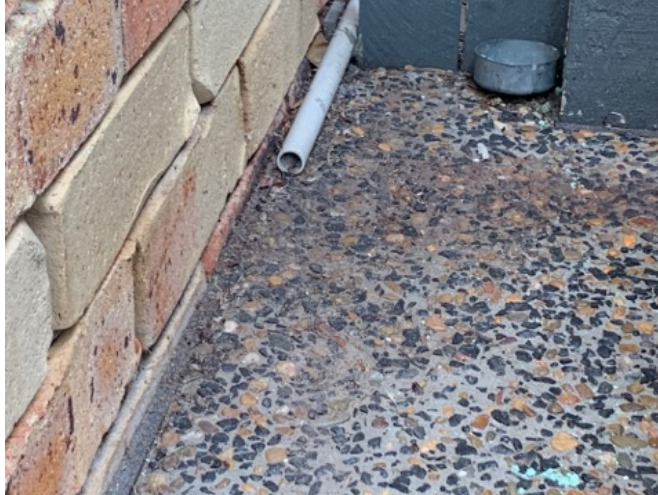
The Air-Conditioning overflow requires diverting to a drain or further from the dwellings wall or footings. Excess water ponding alongside walls and into perimeter footings has the potential to cause rising damp, differential settlement and wall cracks over time. It is also conducive to termite infestation. Recommendations: Engage a plumber to rectify.

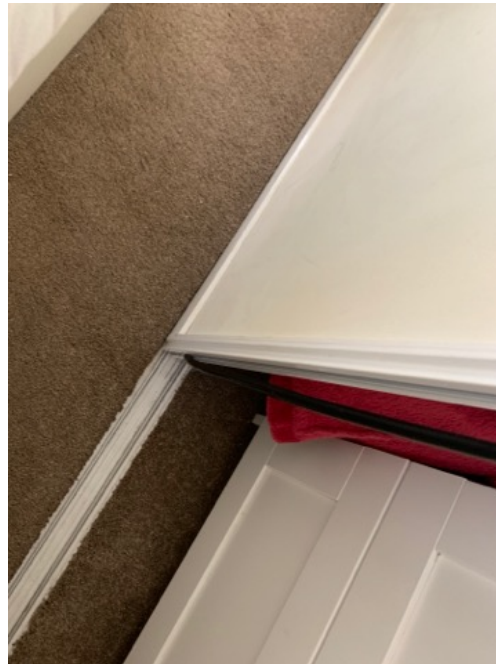
Sliding door trim is loose. Repairs recommended

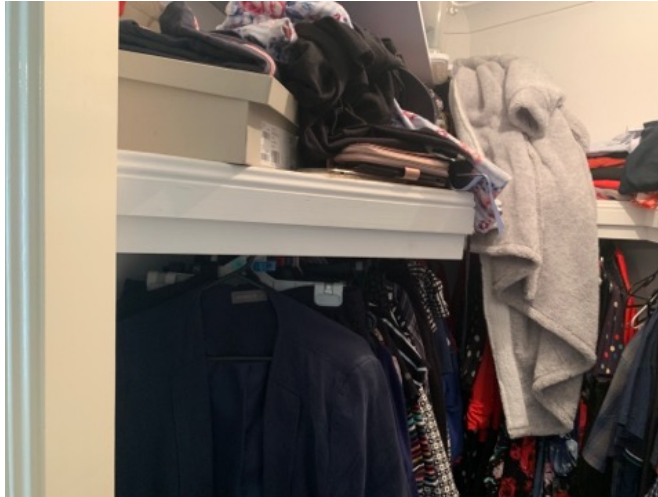
Shelving sagging. Contact a licensed carpenter for repairs

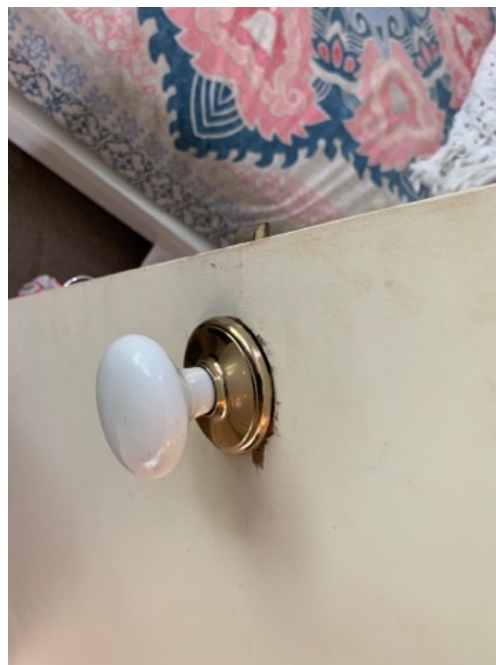
Some Door lock hardware is loose possibly damaged. Maintenance required

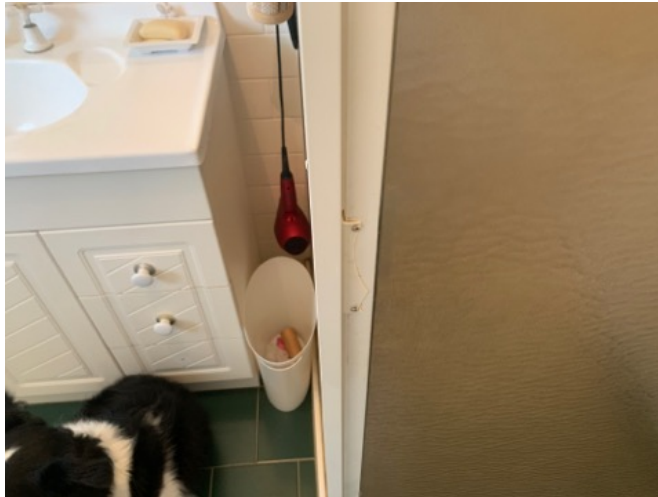
Shower screen handle broken

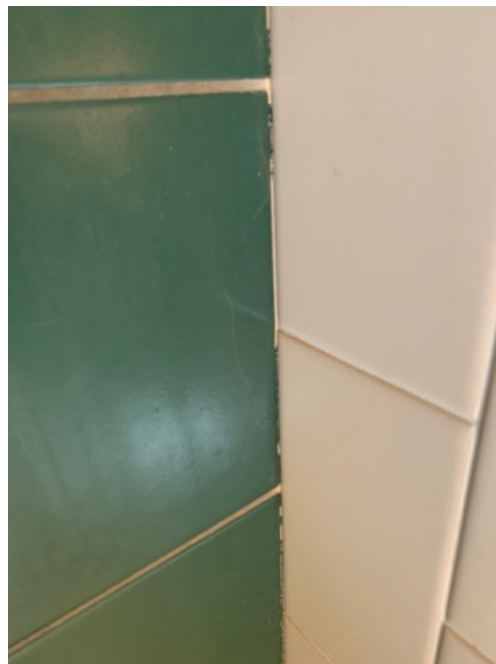
Recommend installing/ replacing silicone sealant to the floor and wall tile Junction. Check and maintain silicone and grouting to all wet areas

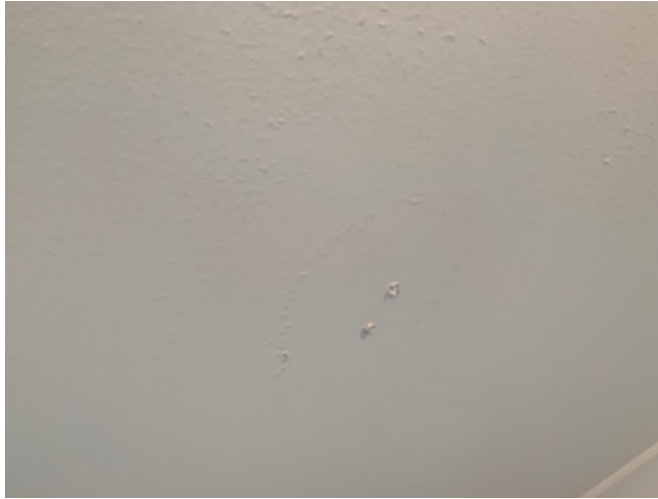
Nail popping observed to the ceiling lining. Patching and painting will improve defects noted.  
Contact a licensed plasterer for repairs

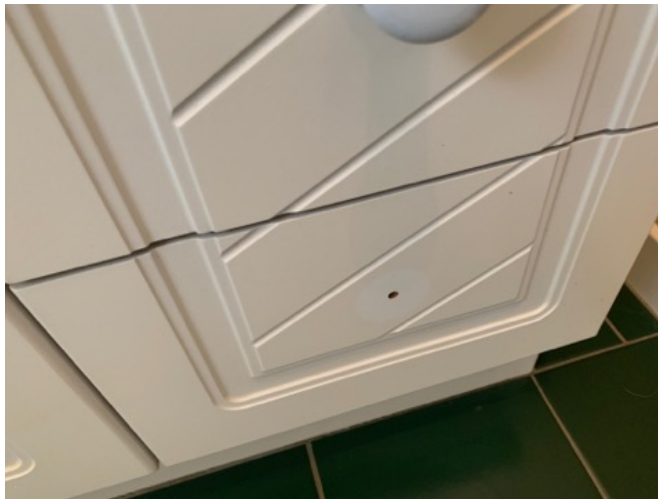
Draw handle missing

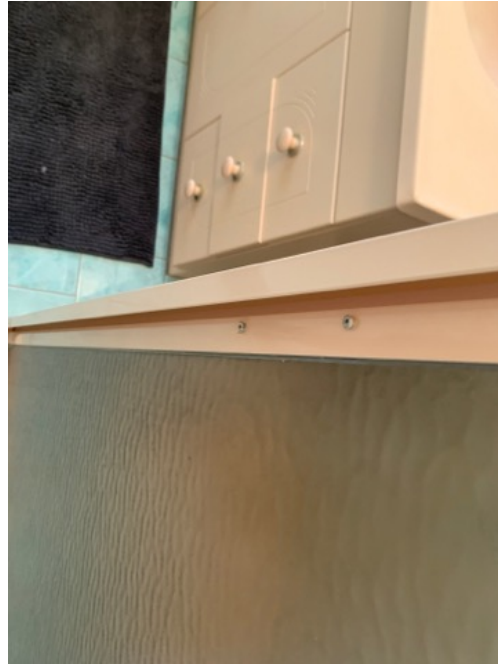
Shower handle broken. Repairs recommended

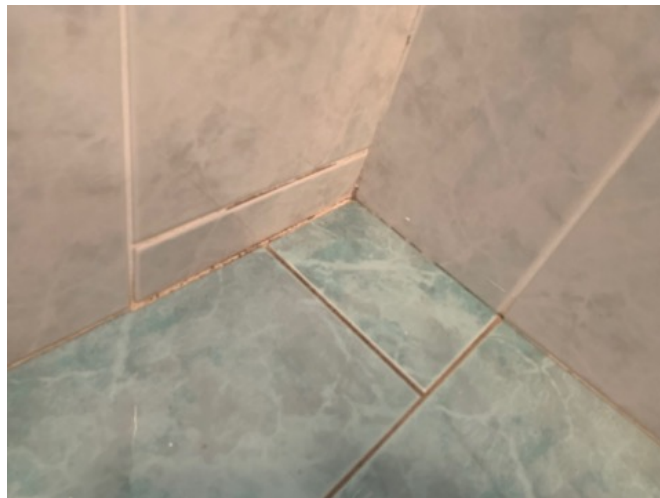
Recommend installing/ replacing silicone sealant to the floor and wall tile Junction. Check and maintain silicone and grouting to all wet areas

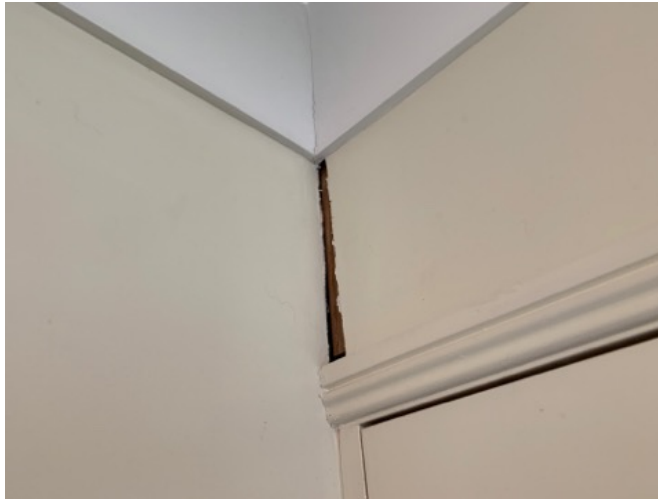
Incomplete Patch/Paint repairs noted. Call a licensed painter for repairs

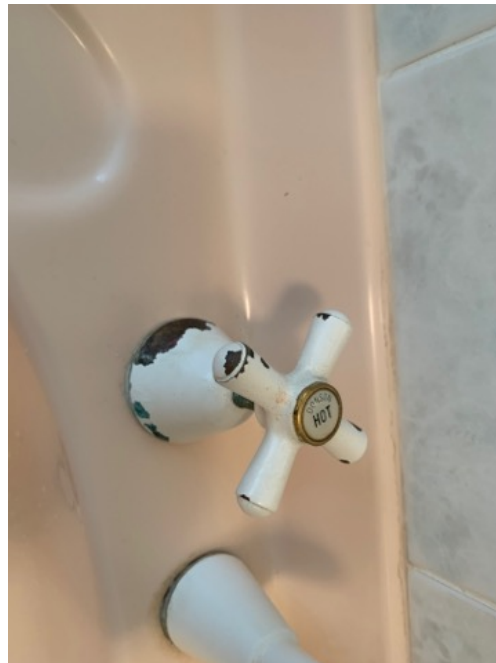
The taps are stiff to open. A qualified plumber should be engaged for advice and recommendations. Normally replacing spindles will rectify.

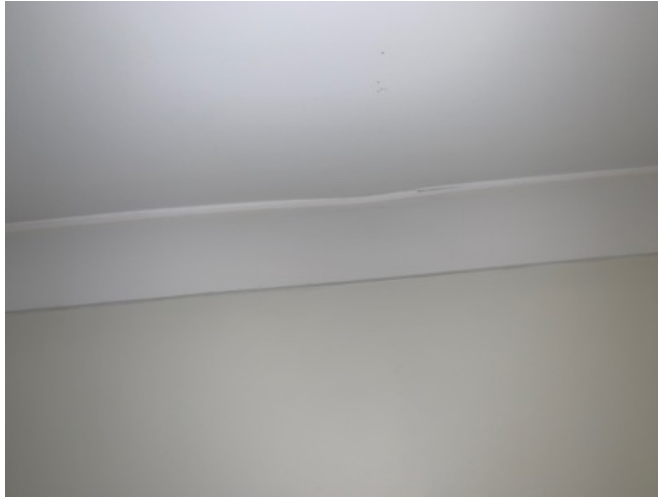
Ceiling truss has deflected causing visual damage to ceiling cornices. This is not considered a structural issue and patching and painting will improve defect noted

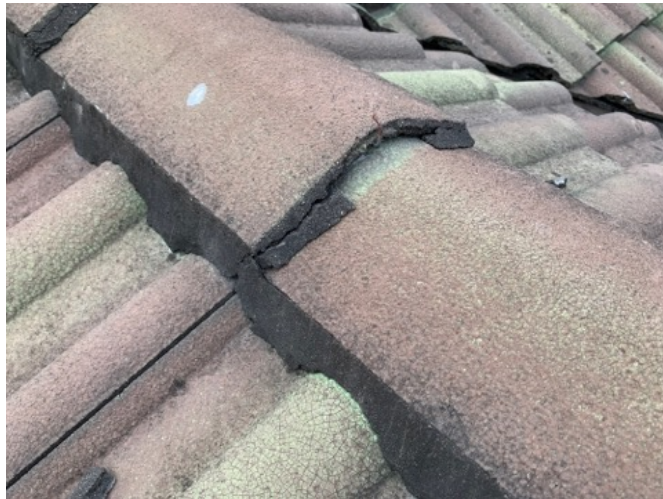
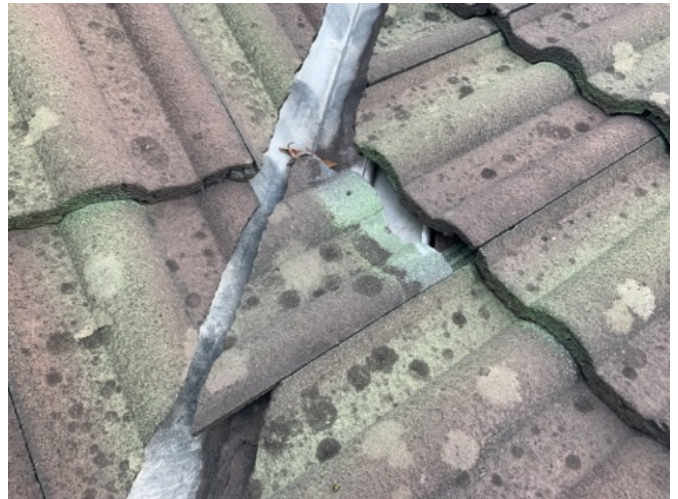
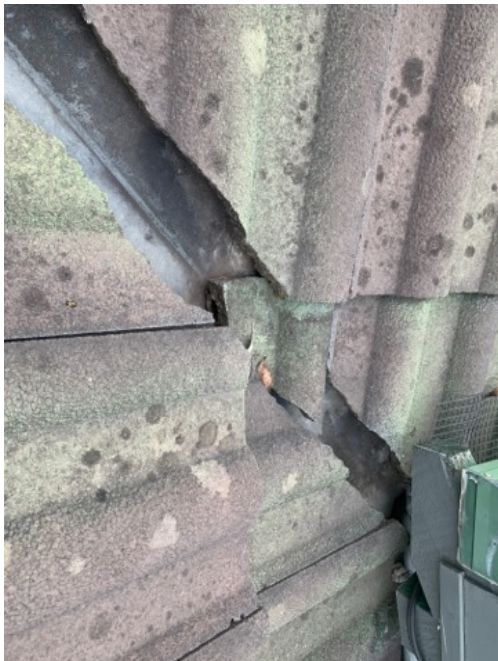
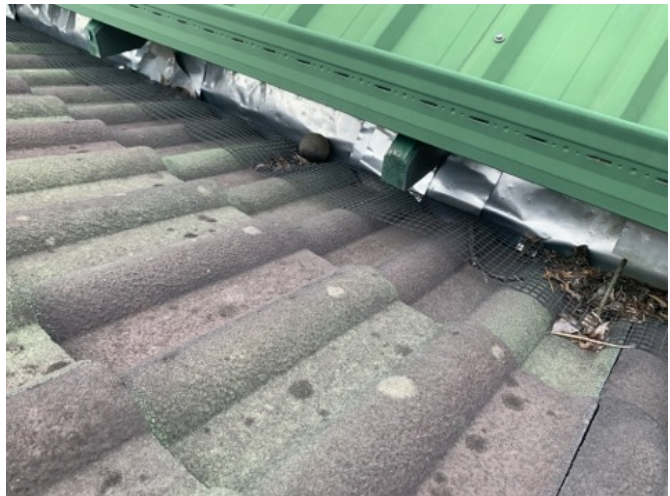
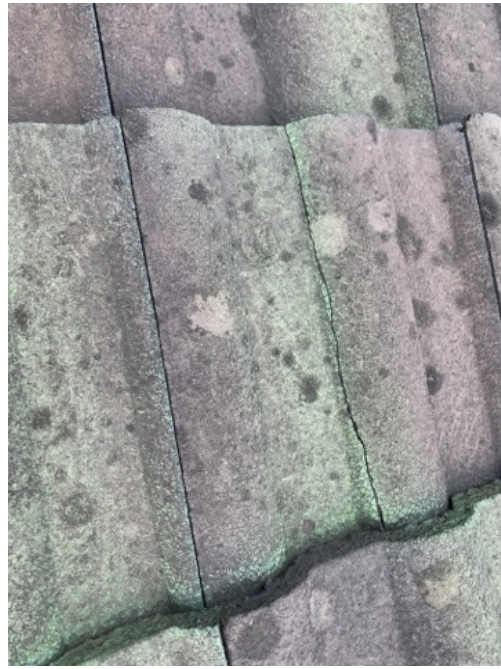
Cracked roof tiles visible - leakage to roof void imminent. Recommendations: A qualified roof tiling contractor should be engaged for immediate repairs.

Minor Mortar/ Pointing cracking. We recommend pointing be repaired by a licensed roofer as This may lead to water entry into the building

Valley tiles are loose and or slipping down. Recommend contacting a licensed roof Tiler for immediate repairs

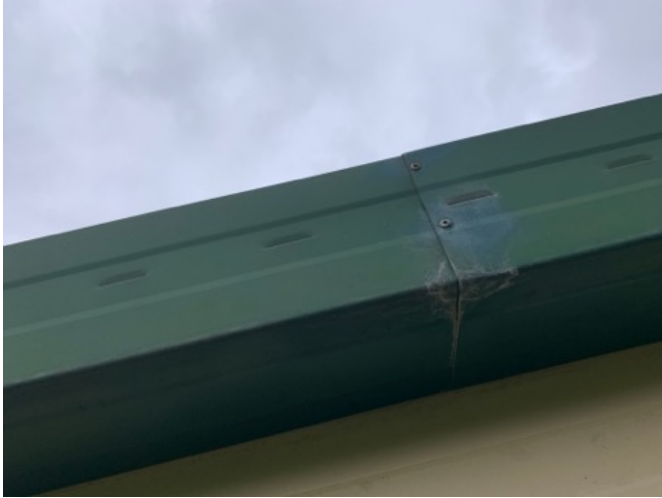
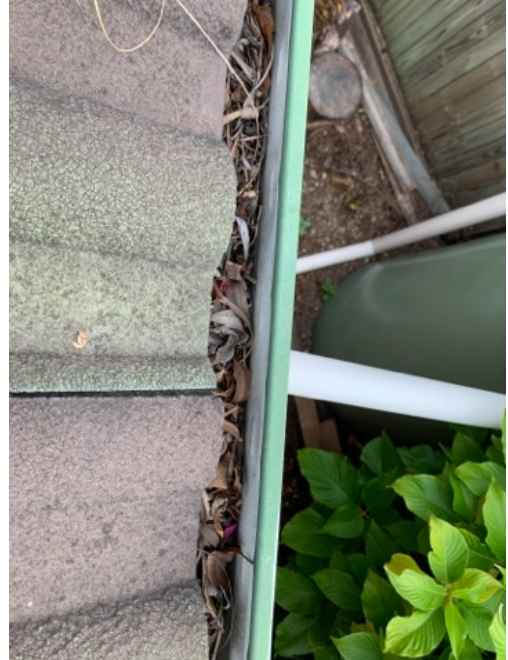
Debris in guttering areas- this requires cleaning out to prevent blocking of down pipes and leaking into eaves and fascia. Recommendations: Have gutters cleaned and assessed by a plumber for adequate fall. Also regularly clean to prevent ponding. Ponding water will contribute to rust.

There is evidence of leaking gutters. Contact a roof plumber for advice and repairs.

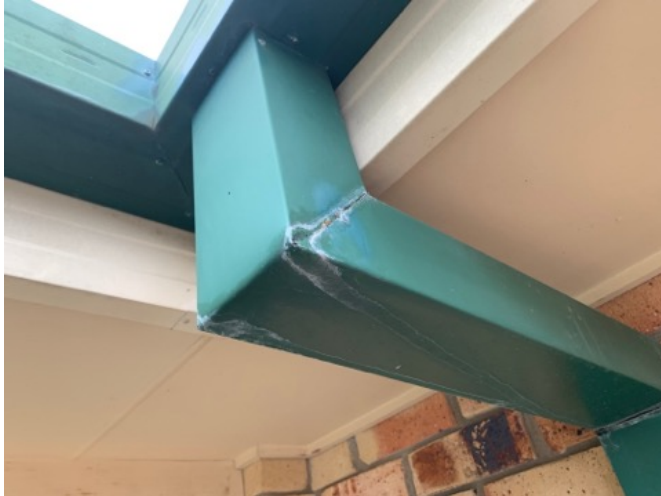
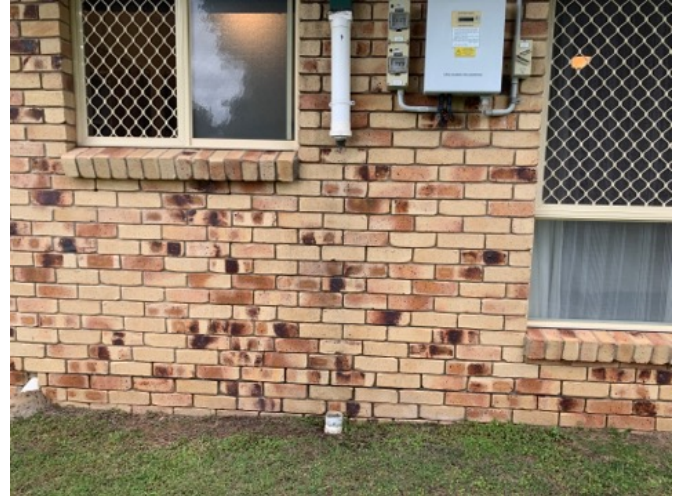
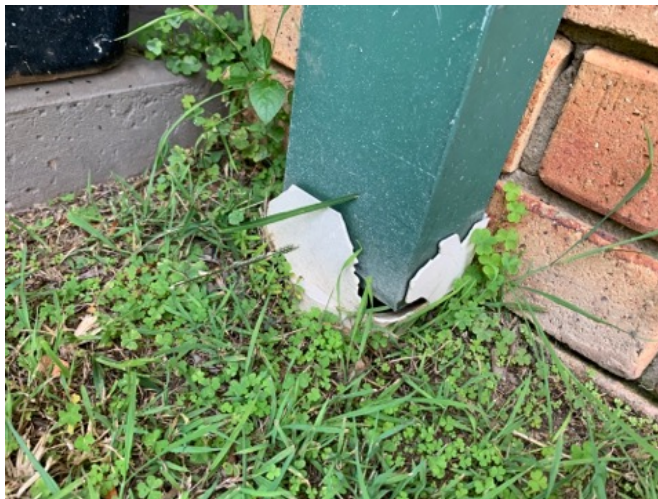
Leaking down pipe joins visible. This can be conducive to termite infestation and cause water damage to cladding over time. Recommendations: A qualified roof plumber should be engaged to repair.

The down pipe base is damage/cracked. This has the potential to cause leaking next to house. Recommendations: A qualified plumber should be engaged for repairs.

Insufficient in the inspectors opinion. Due to being disconnected. Contact a roof plumber for further advice and recommendations

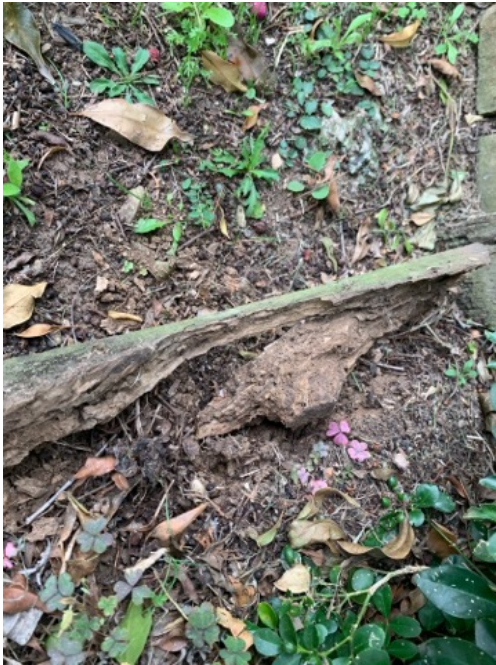
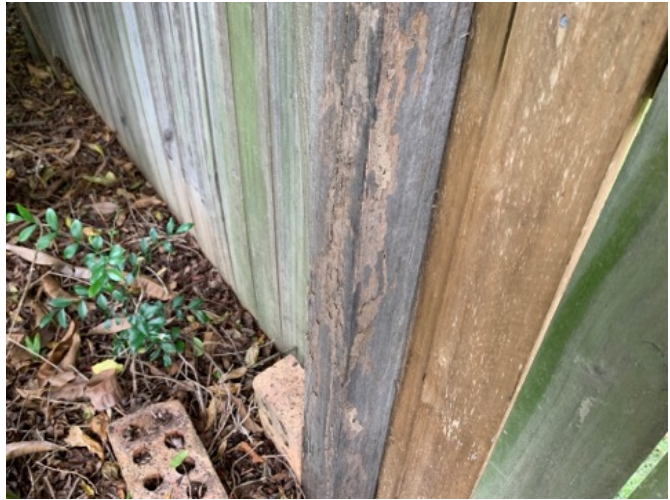
Timber fence

Garden timbers

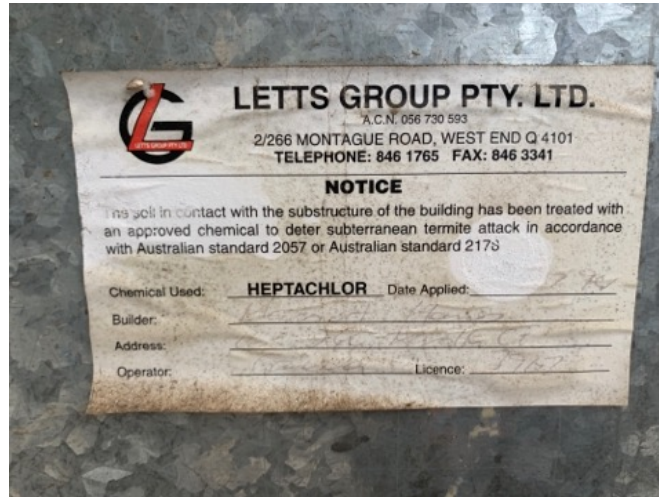
Treatment notice found in meter box for EXPIRED chemical treatment

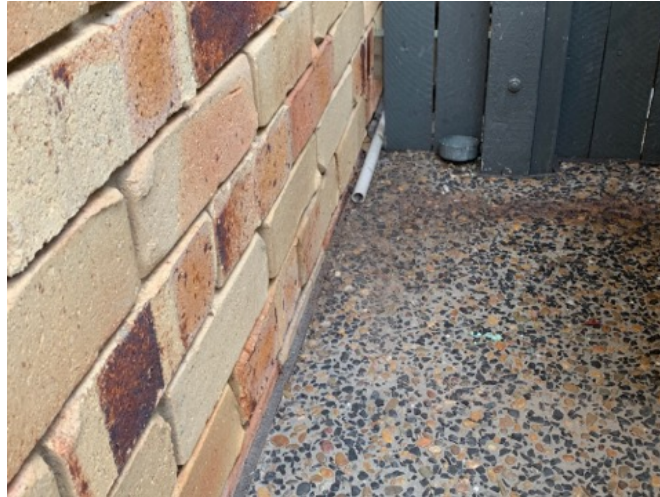
No - Air conditioning units which release water alongside or near to building walls need to be connected to a drain (if this is not possible then their water outlet needs to be piped several meters away from the building) as the resulting wet area is highly conducive to termites.

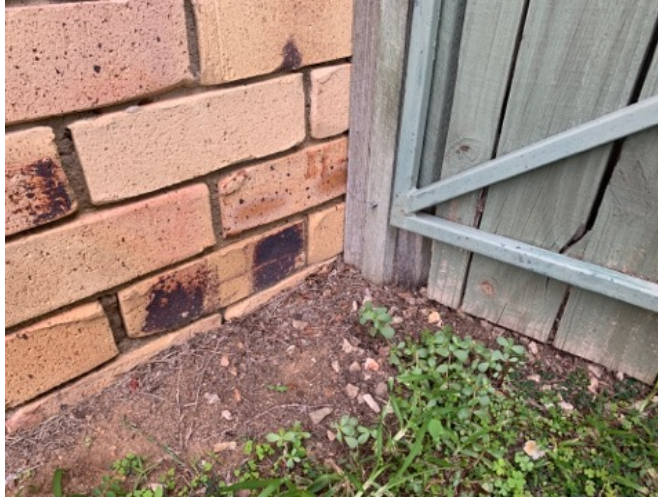
Any timbers eg' fence post, pergola timbers, decking etc which is attached to the side of the home and in direct ground contact can provide a concealed TERMITE entry point. A clearance of 75mm from finished ground level is required. Where this is not practical then a chemical barrier would be considered essential.
